Effect of CFRP bond length on repair of composite steel girders with a cracked flange

A. Shaat & A. Fam
Queen's University, Kingston, Ontario, Canada

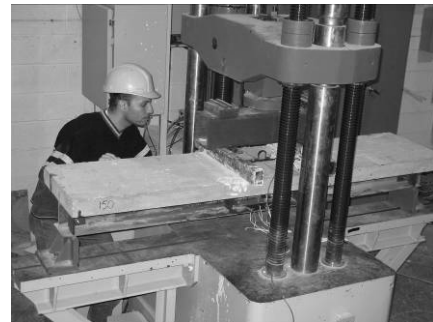
Figure 2. Test setup

The specimens were tested as simple beams with a span of 1960 mm. The beams were monotonically loaded in four-point bending, as shown in Figure 2, with a distance of 400 mm between the applied loads. Short angle sections were bolted to the web from both sides and used as stiffeners under the loading and supporting points. Two linear potentiometers (LPs) were mounted on both sides of the beams, at mid-span, to measure the vertical deflection. Strains in the longitudinal direction were also measured. The load was applied to failure using stroke control at a rate of 0.75 mm/min.

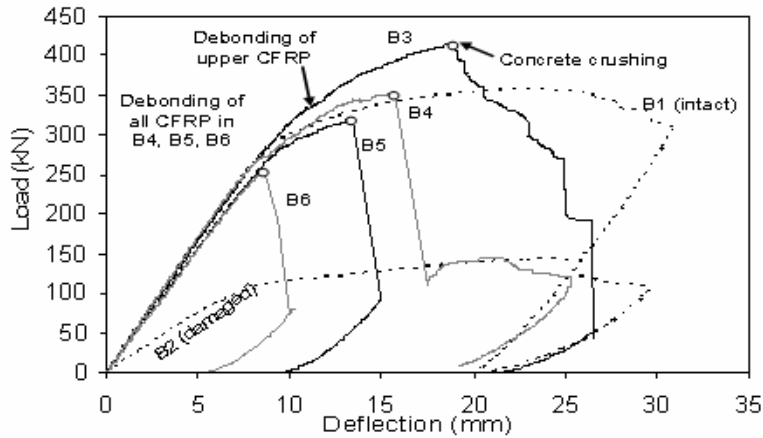
Figure 3. Load-deflection responses of test beams

Figure 3 shows the load versus mid-span deflection of the control intact beam B1 and the control damaged beam B2. The figure shows that both the strength and stiffness have been severely degraded as a result of the complete cutting of the lower steel flange at mid-span. Table 2 reports 60 and 54 percent reductions in flexural strength and elastic stiffness, respectively. The

Figure 3 shows that B3 with a 1900 mm bond length (97% of the span) has fully recovered the flexural strength and stiffness of the intact control beam and even exceeded them. The total bond length for B4 was 1000 mm, whereas for B5 and B6, the total bond lengths were 250 and 150 mm, respectively (i.e. completely within the 400 mm constant moment zone). Figure 5(a) shows the variation of the ultimate load, normalized to that of control beam B1, with the bond length, normalized to the span length ($L_{sheet}/Span$). A bi-linear trend is observed, with the steep part of the curve being within the constant moment zone, while the shallow part being within the shear span. Generally, the behaviour clearly shows a reduction in ultimate load with shortening the bond length of CFRP. As given in Table 2, B3 with CFRP sheets bonded along 97 percent of the span achieved a 16 percent higher strength than the intact beam B1. Beam B4, with a 1000 mm bond length (51 percent of span) achieved a load equals to that of the control beam B1. Beams B5 and B6 with bond lengths of 12.8 and 7.7 percent of the span, respectively, failed at lower loads, 10 and 28 percent lower than B1, respectively. Table 2 also shows that unlike the flexural strength recovery, the elastic stiffness of the intact beam B1 has generally been recovered in all beams (B3 to B6), regardless of the bond length, with little variations. Figure 3 also shows the effect of the bond length on the deflection of the repaired beams. The deflection at ultimate and the length of the nonlinear part of the curve reduced as the bond length was decreased. Figure 5(a) suggests that the optimum total bond length would be about 55 percent of the span for this particular beam configuration and force equivalence index.
